Water Compliance Inspection Report

**NPDES
INSPECTION REPORT**

**SIMPLOT LAND AND LIVESTOCK
J.R. SIMPLOT COMPANY
GRANDVIEW, IDAHO**

JULY 27, 2011

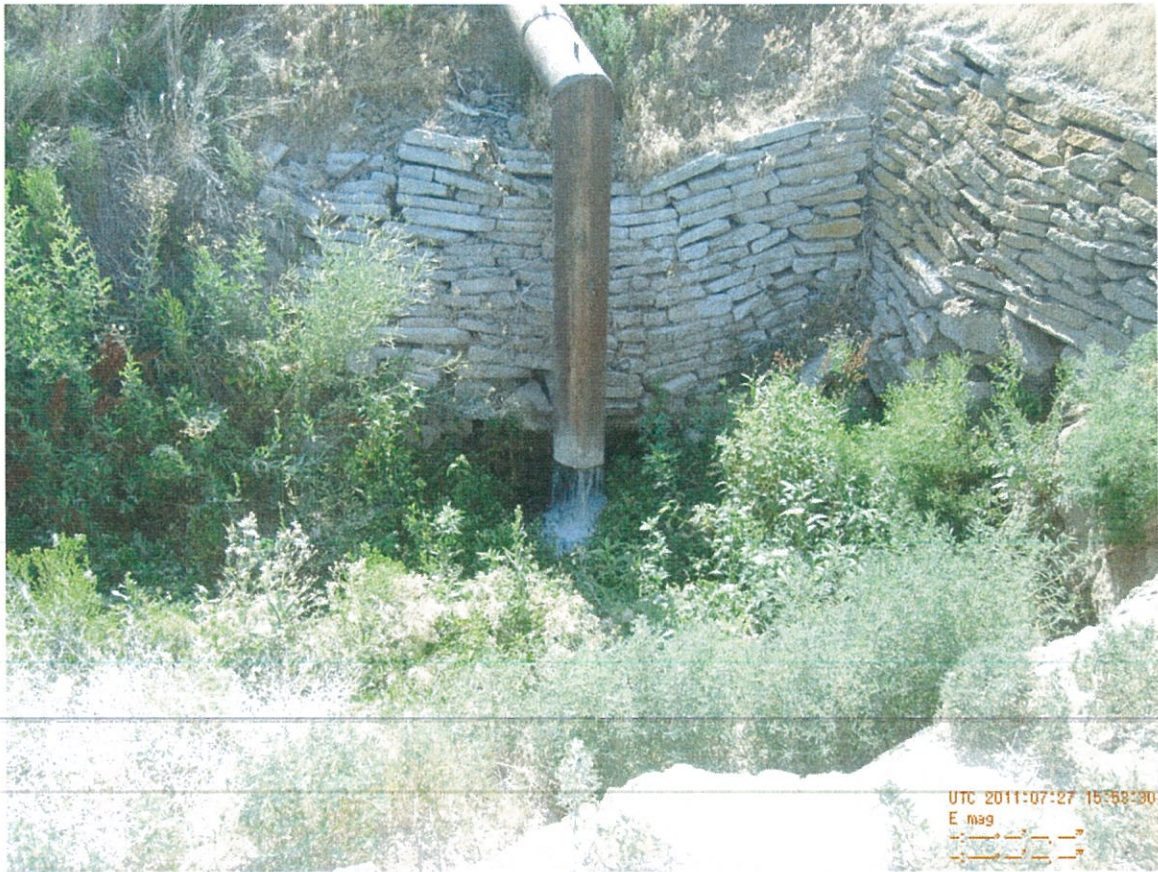
Photograph 1: Facing east, the photograph shows where Mr. Ron Parks of Simplot stated that the source water overflow used to discharge into a ditch, which eventually flowed to the Ted Trueblood Wildlife Reserve and the Snake River. Mr. Parks stated that the current water discharging from the pipe was irrigation water.

We began the inspection along Geo Bennett Road and stopped and looked at the first discharge pipe (Photographs 1 and 2). At the time of the inspection, water was still flowing out of the pipe. According to Mr. Parks, the source of the water was irrigation water. I asked Mr. Parks how this discharge was different from the discharge that EPA inspectors observed on their March 12, 2009 inspection. Mr. Parks stated the quantity of water coming out of the pipe now is substantially less from what the EPA inspectors observed on March 12, 2009 (50 gpm versus 1700 gpm). In addition, the irrigation water is not available in the month of March. Therefore, the discharge that was observed on March 12, 2009 was strictly stock water from the Facility.

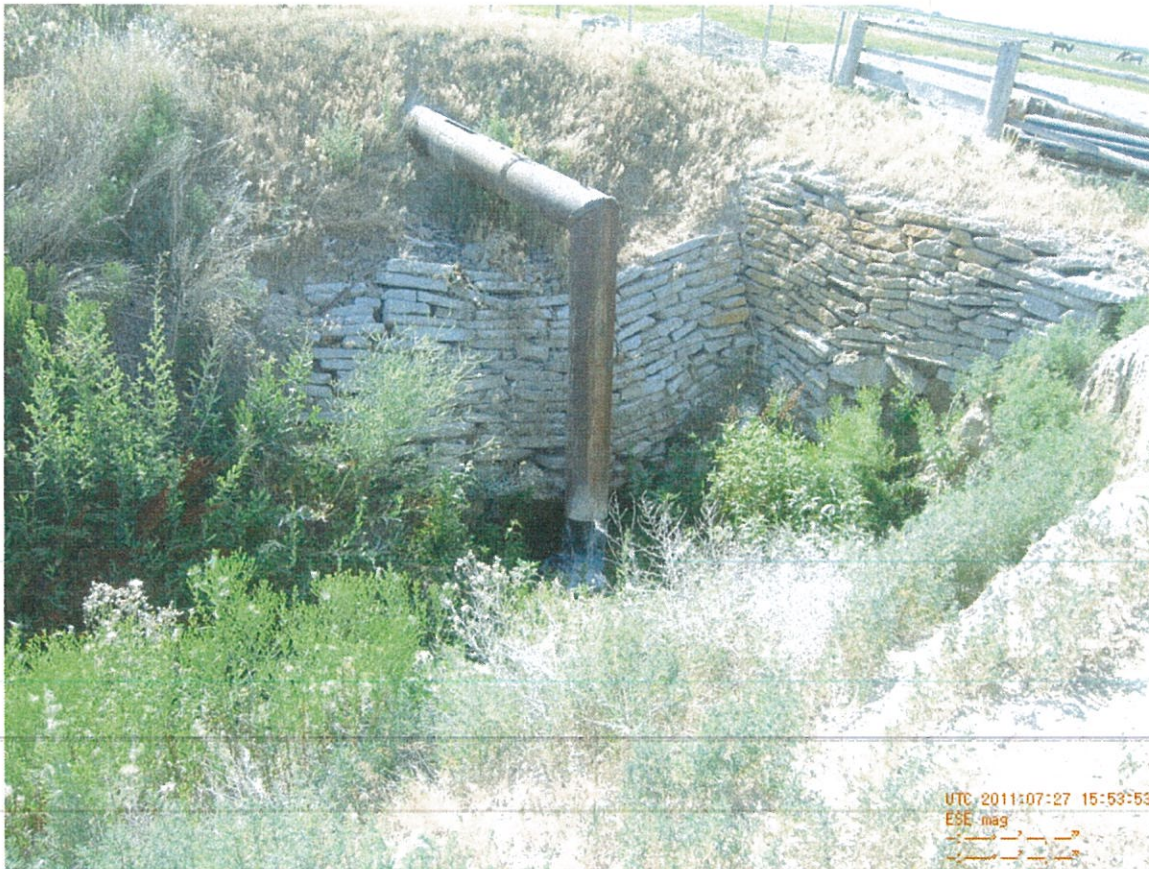
Photograph 2: Facing southeast, the photograph shows where Mr. Ron Parks of Simplot stated that the source water overflow used to discharge into a ditch, which eventually flowed to the Ted Trueblood Wildlife Reserve and the Snake River. Mr. Parks stated that the current water discharging from the pipe was irrigation water.

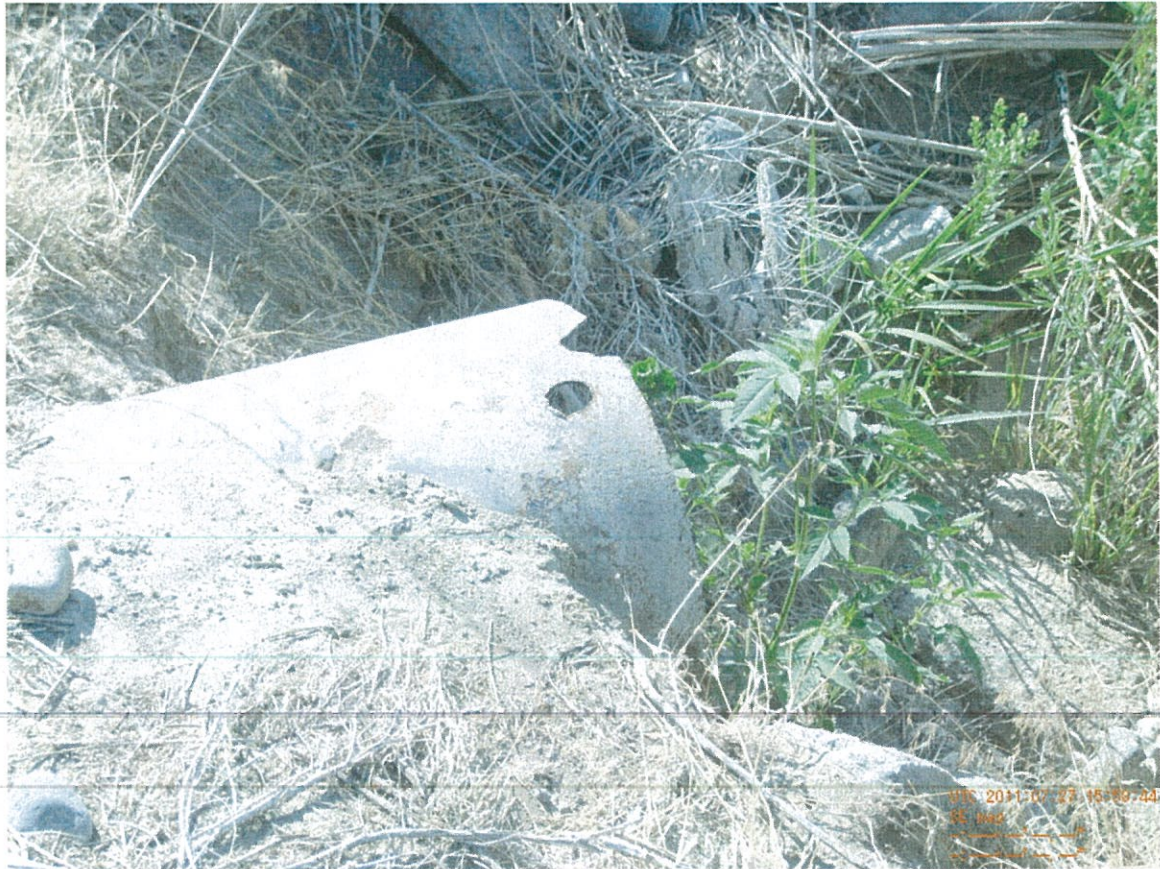
Photograph 3: Facing southeast, the photograph shows where the source water overflow was discharged into a ditch, which then mixed with the irrigation water shown in photographs 1 and 2. There was no discharge from the pipe at the time of the inspection.

We proceeded further north on Geo Bennett Road where Mr. Parks showed us a second pipe. Photographs 3 and 4 show this pipe, note there is no discharge from this pipe into the irrigation canal. Prior to modifications made to the stock watering system, this pipe used to discharge the overflow from the stock watering system where it would co-mingle further south on the irrigation canal with irrigation water (Photographs 1 and 2).

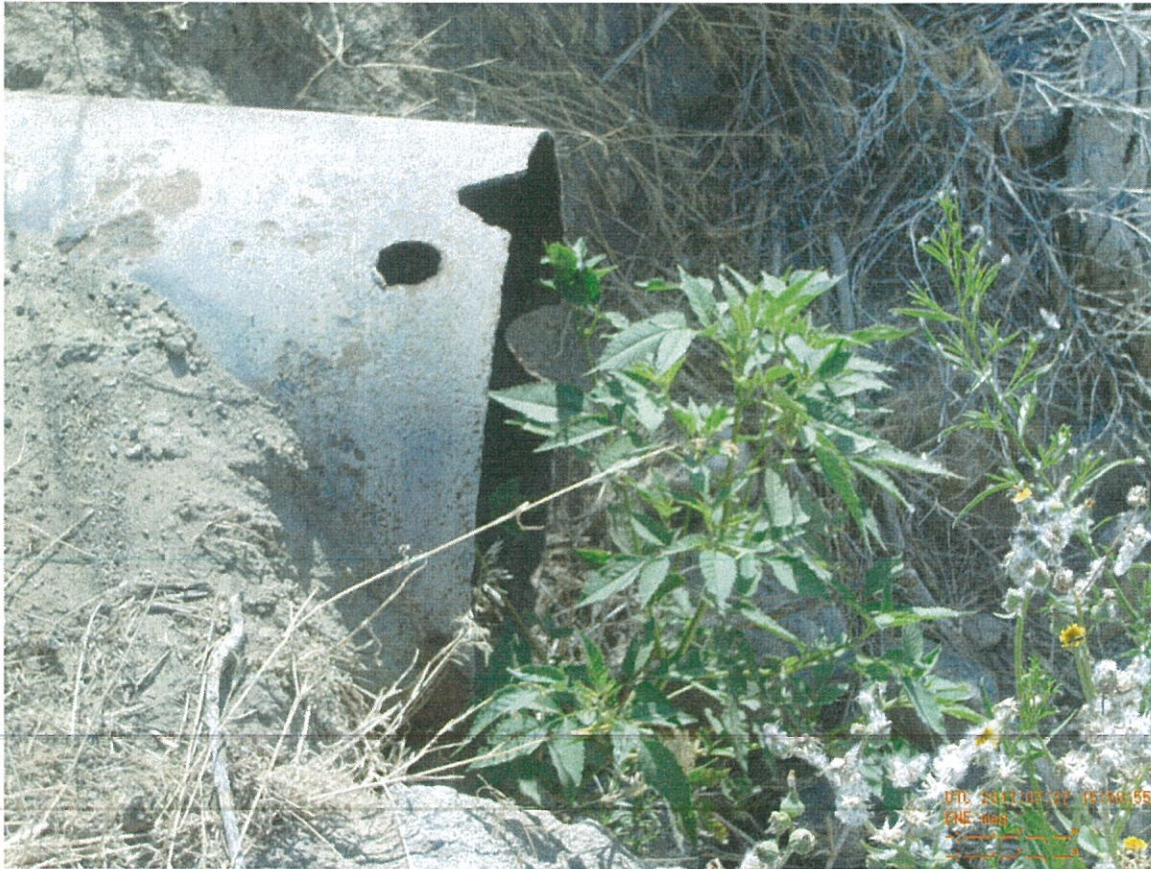
Photograph 4: Facing east, the photograph shows where the source water overflow was discharged into a ditch, which then mixed with the irrigation water shown in photographs 1 and 2. There was no discharge from the pipe at the time of the inspection.

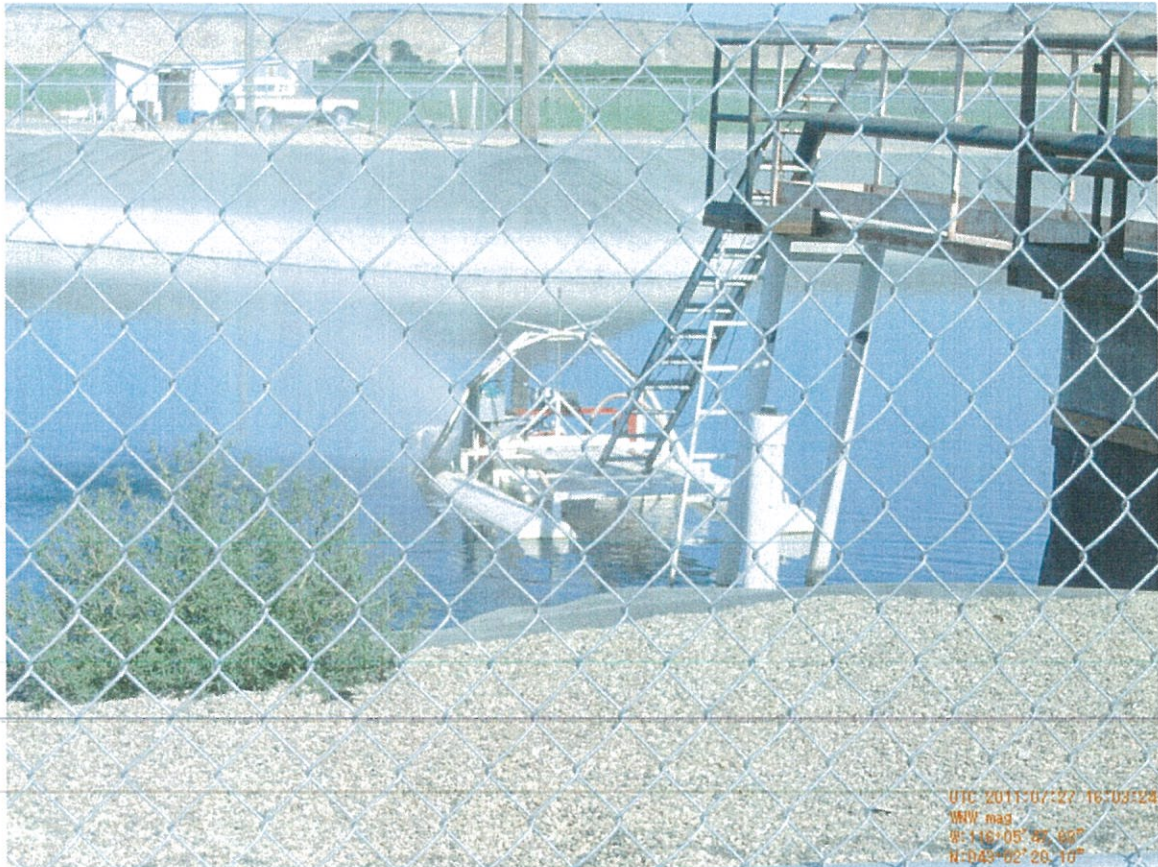
Photograph 5: Facing northwest, the photograph shows the lined storage pond that Simplot constructed to contain, treat, and recirculate the source water overflow for watering cattle, and dust suppression.

The storage pond is lined and has a capacity of 3 million gallons of stock water and is between 17 – 18 feet deep which includes 3 feet of freeboard, according to Mr. Parks (Photographs 5, 6, 15, and 17). The highest level of water observed in the storage pond has been 15 feet. There is a fail-safe that touches the water in the pond if it gets to a certain level and sounds an alarm to shut down all inputs of water. According to Mr. Parks, all inputs to the storage pond are ground water sources. We noticed that the sides of the storage pond had gravel placed over the liner. According to Mr. Parks, this is to allow an individual to climb out of the lagoon in case of an accident. The perimeter of the lagoon is also fenced as a safety measure.

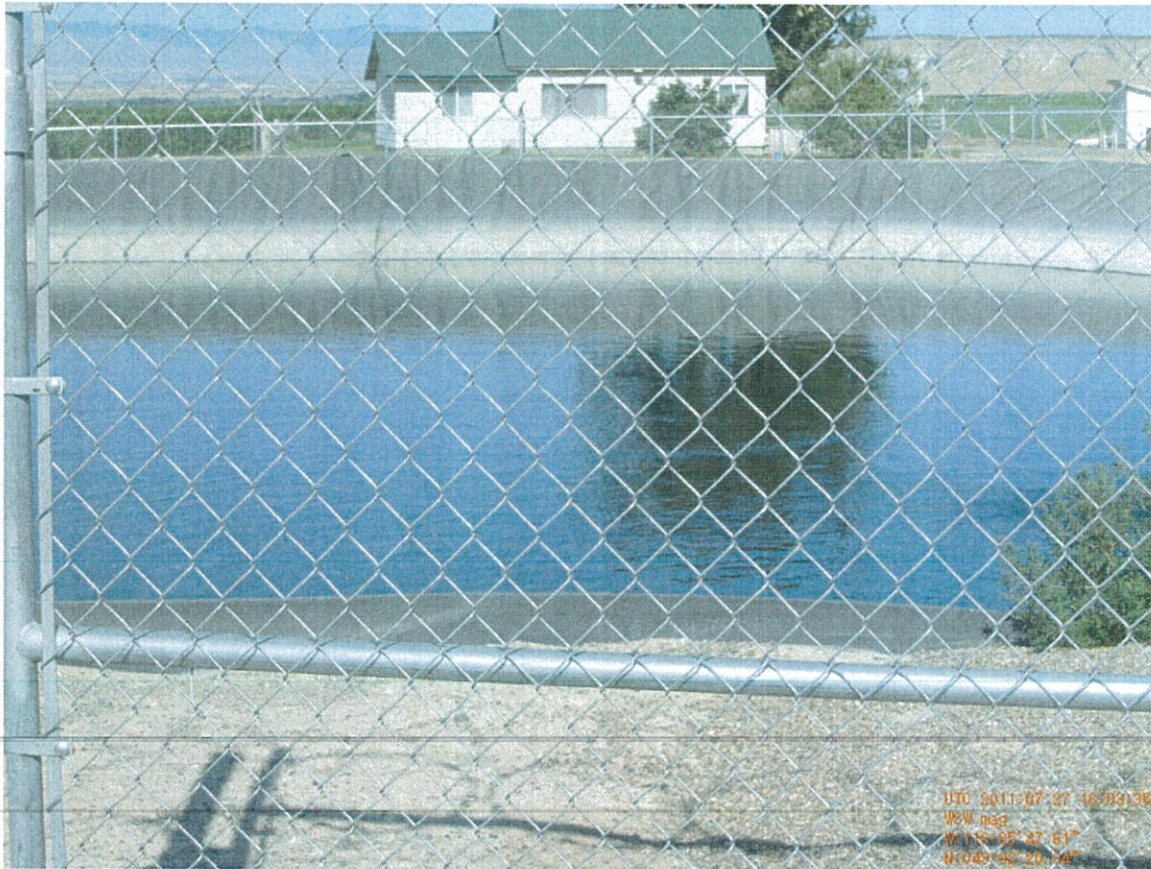
Photograph 6: Facing west, the photograph shows the lined storage pond that Simplot constructed to contain, treat, and recirculate the source water overflow for watering cattle, and dust suppression.

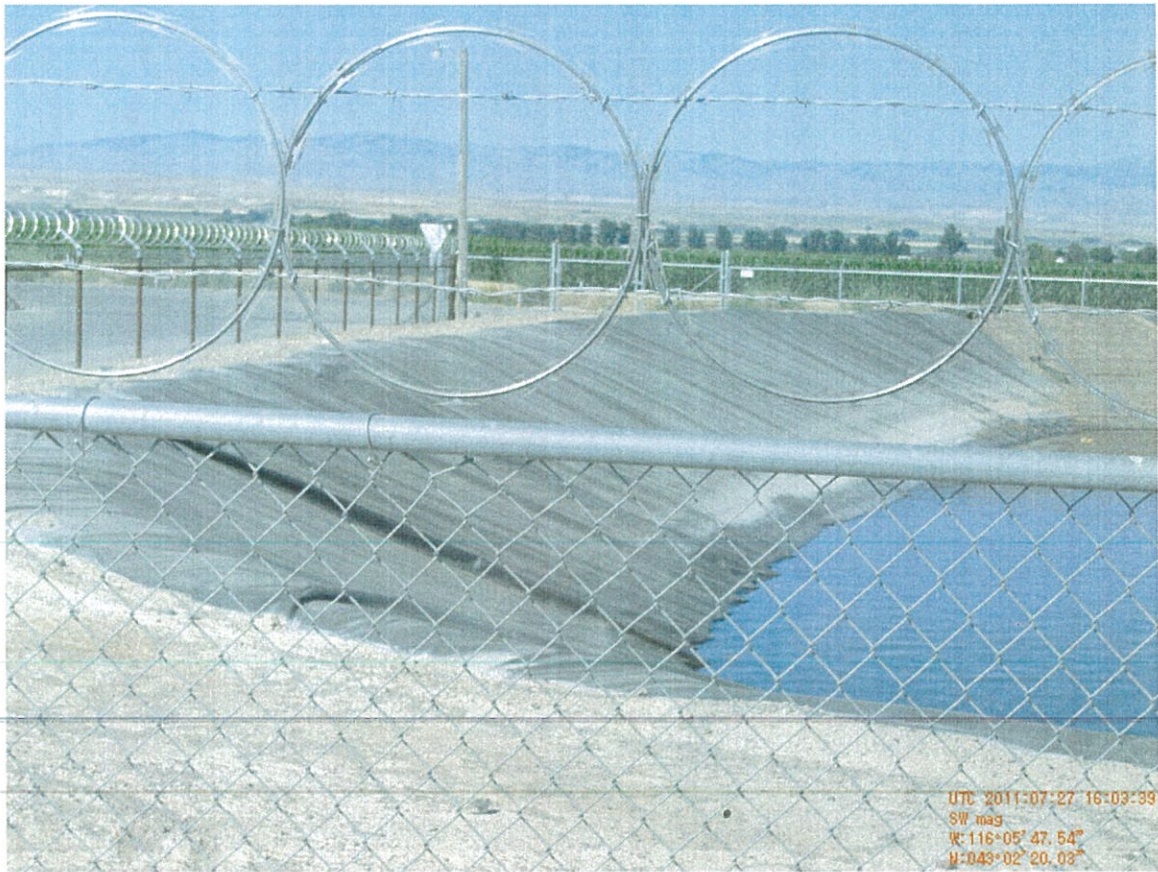
Photograph 7: Facing southwest: the photograph shows the lined storage pond that Simplot constructed to contain, treat, and recirculate the source water overflow for watering cattle and dust suppression. Simplot placed gravel over the synthetic liner in the top right portion of the photo to allow an individual to climb out of the lagoon in case of an accident.

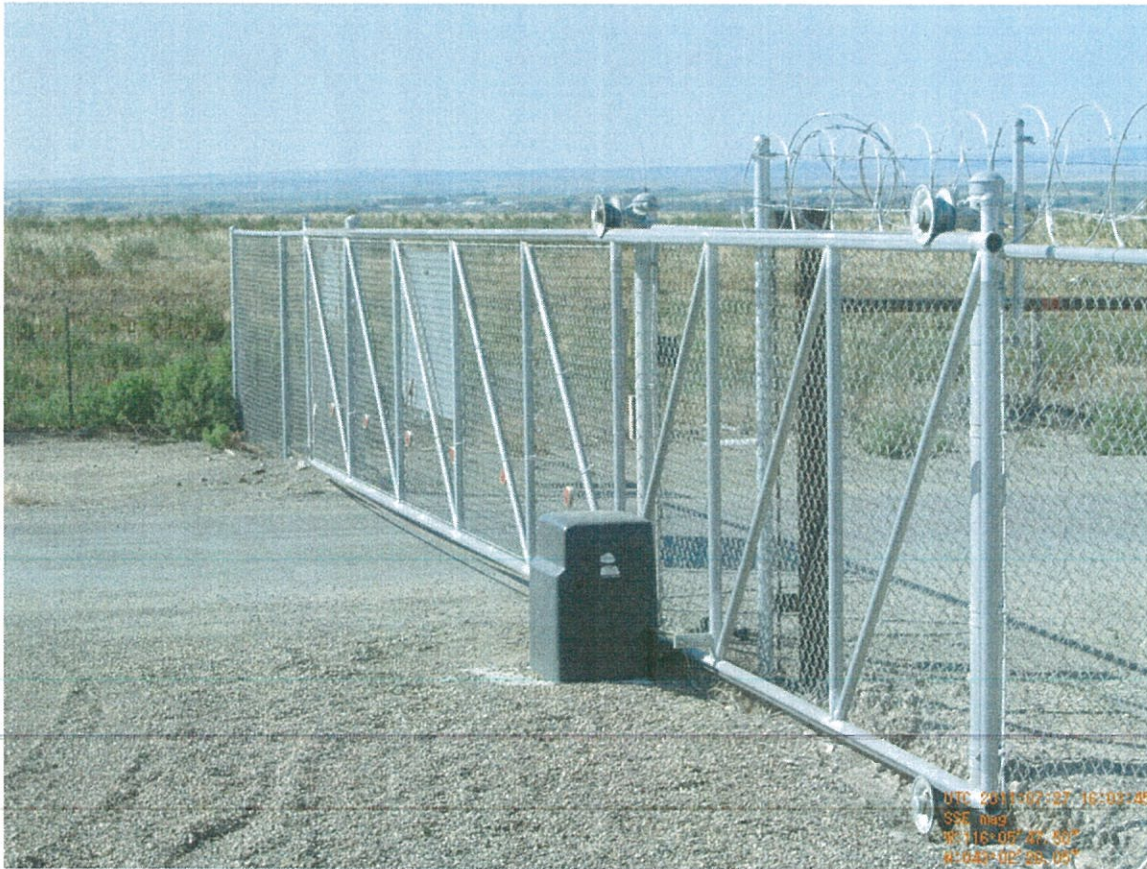
Photograph 8: Facing south, the photograph shows the security gate allowing for Simplot staff or officials to enter the area where the storage pond, pumps, and computer system is housed.

We then proceed to a security gate (Photograph 8) where the Facility houses the newly expanded storage pond, pumps, and control panel for the stock watering system. Mr. Purdy, technician for the computerized system, described how the system works (Photograph 10). According to Mr. Purdy, the newly installed computer system is similar in function to a Supervisory Control and Data Acquisition (SCADA) system at a drinking water plant. The operator is able to manage the water in the storage pond and use it for drinking water for cattle or dust suppression. The computerized system can be managed remotely and the technician is able to make changes and reprogram at-will. The stock water system consists of three pumps capable of 3800 gpm.

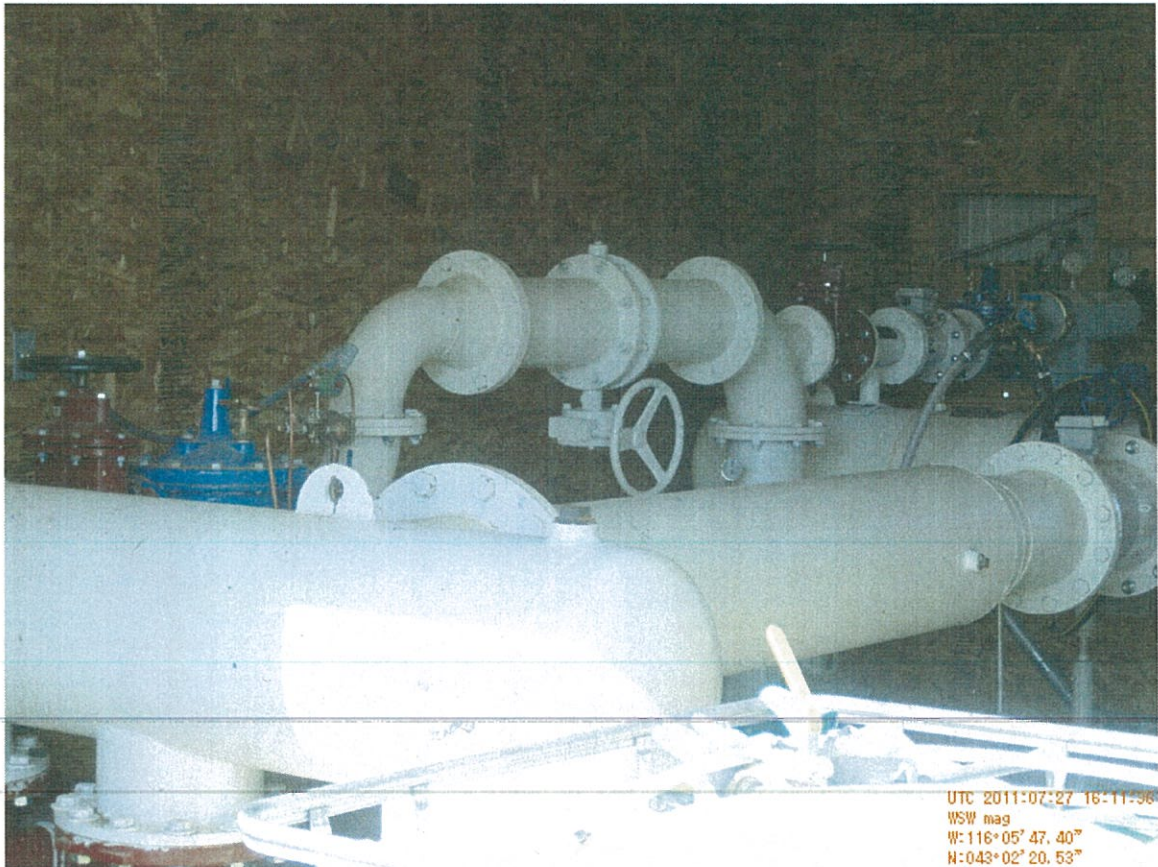
Photograph 9: Facing west, the photograph was taken from the outside of a garage door into a building housing the computer control system, generator, and the pumping and valve systems for controlling and recirculating the source water overflow in the storage pond.

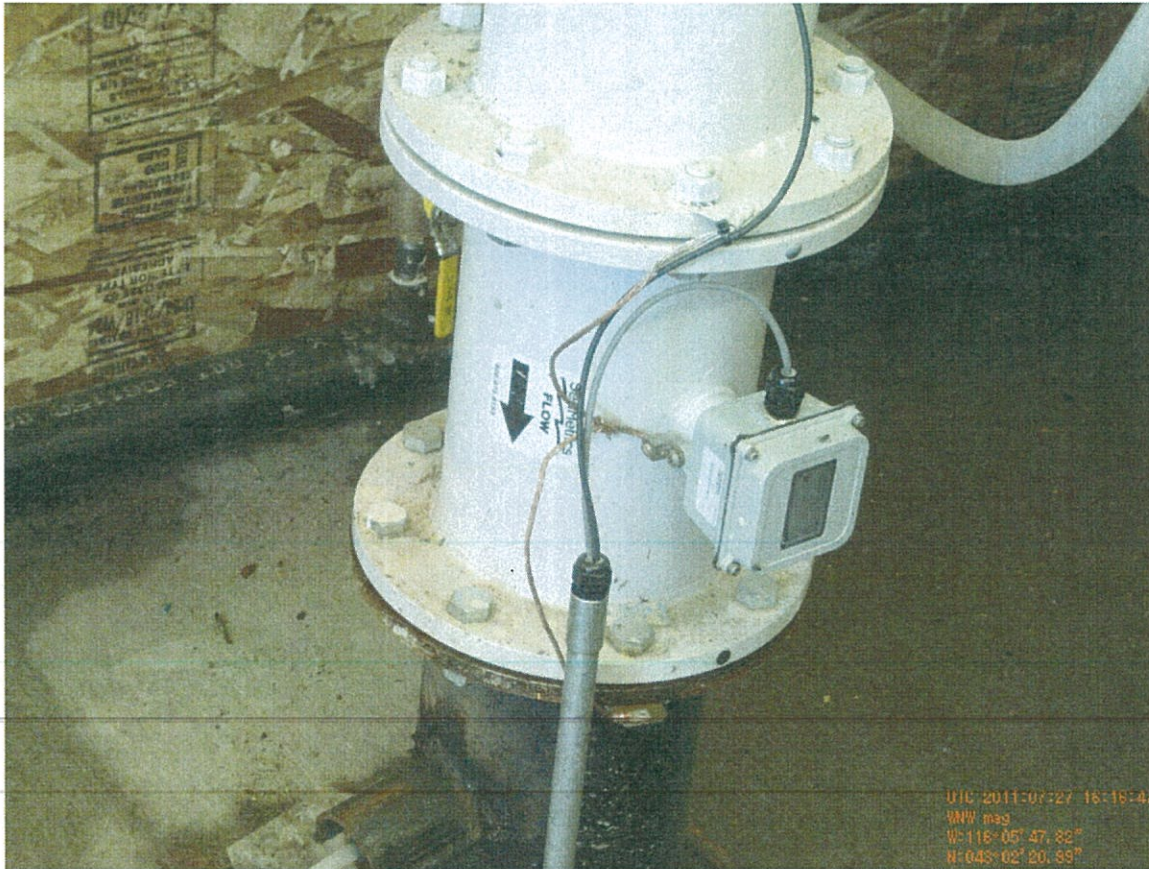
Photograph 11: Facing west, the photograph shows where chlorine is inserted into the recirculating source water for disinfection prior to providing the water to cattle for drinking water.

The stock water in the storage pond which is used as a drinking water source for cattle is first disinfected with chlorine (Photograph 11). During our inspection, the Facility was in the process of swapping out chlorine tanks and was not using the chlorine. According to Mr. Parks, the stock tanks for drinking water need to have some quantity of water in the tanks to keep them from freezing. The stock tanks have a float to keep water in the tank at a particular level to prevent freezing during winter.

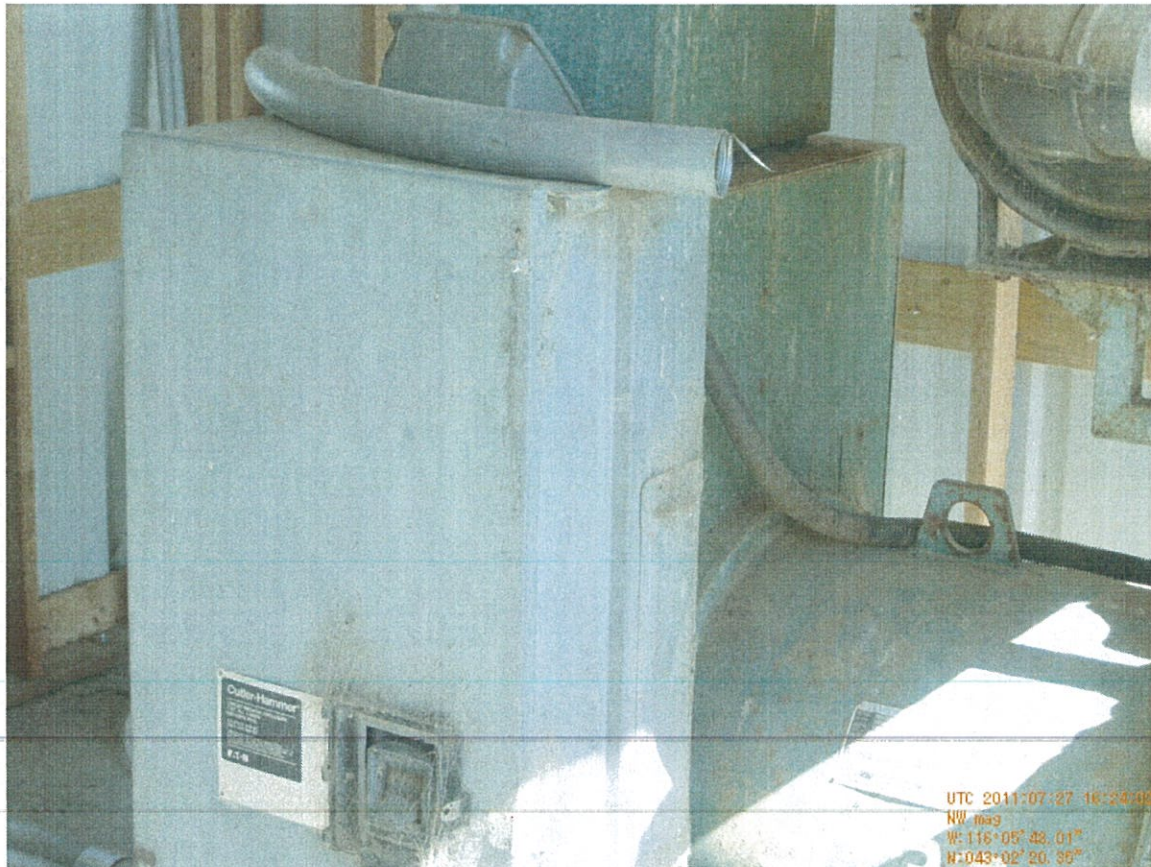
Photograph 12: Facing northwest, the photograph shows the generator used as a backup power supply for the storage pond.

According to Mr. Purdy and Mr. Parks, the Facility has a generator for back-up power (Photograph 12- 14) and shouldn't overflow. We observed a diesel tank near the storage pond. This tank is used to fuel the back-up generator in case of power outage (Photograph 16). In addition to the generator, a catch basin is located to the south of the storage pond. According to Mr. Parks, this is an additional measure in case of an overflow. However, Mr. Parks doesn't expect to ever have to use the catch basin.

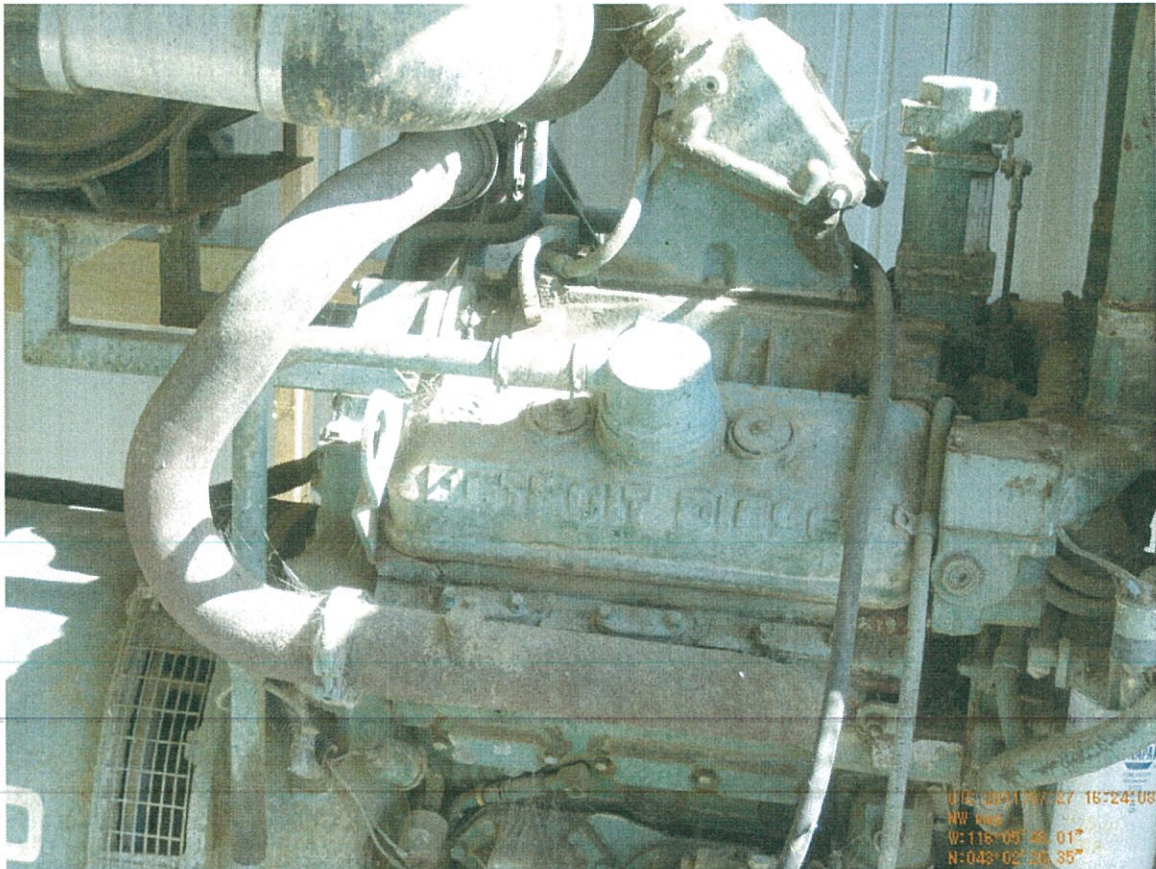
Photograph 13: Facing northwest, the photograph shows the generator used as a backup power supply for the storage pond.

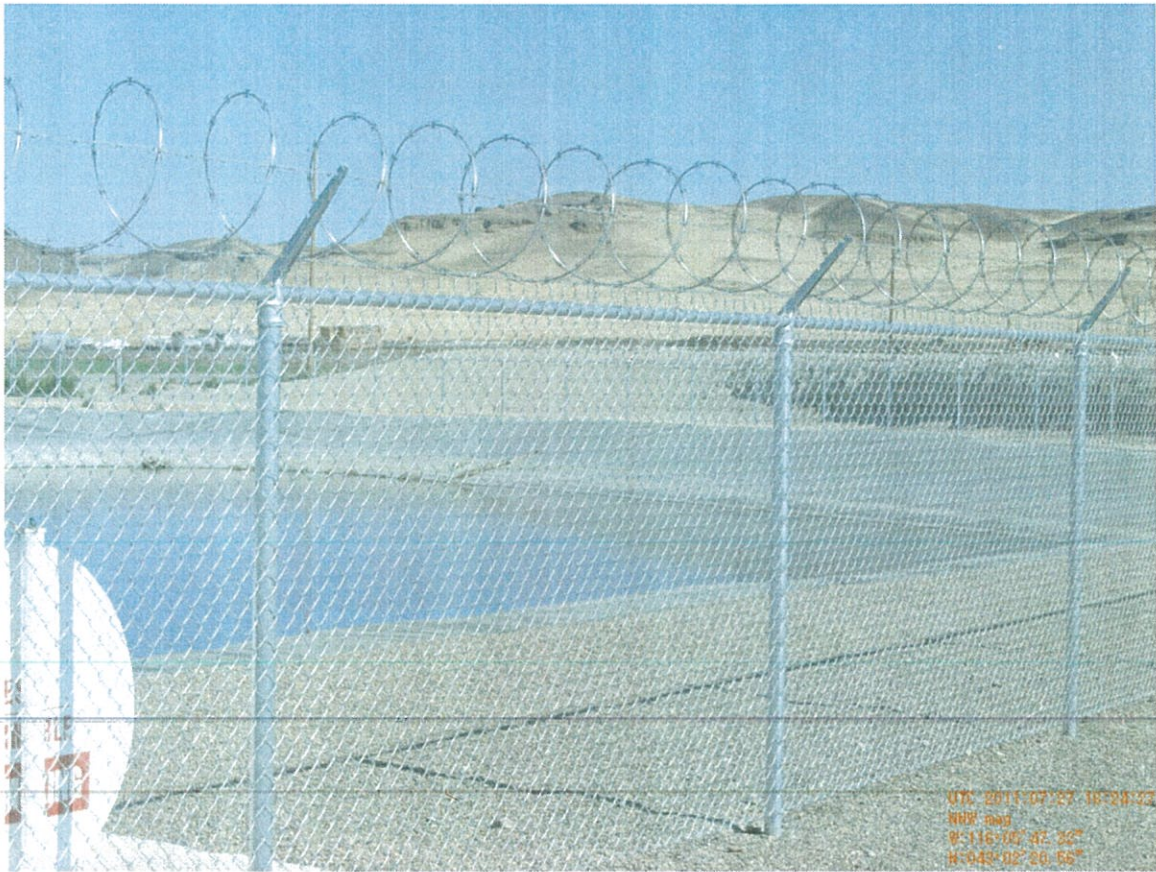
Photograph 15: Facing northwest, the photograph shows the lined storage pond, the security fence surrounding the pond, and a diesel tank for the backup generator. Mr. Parks of Simplot stated that the diesel tank was approximately 500 gallons.

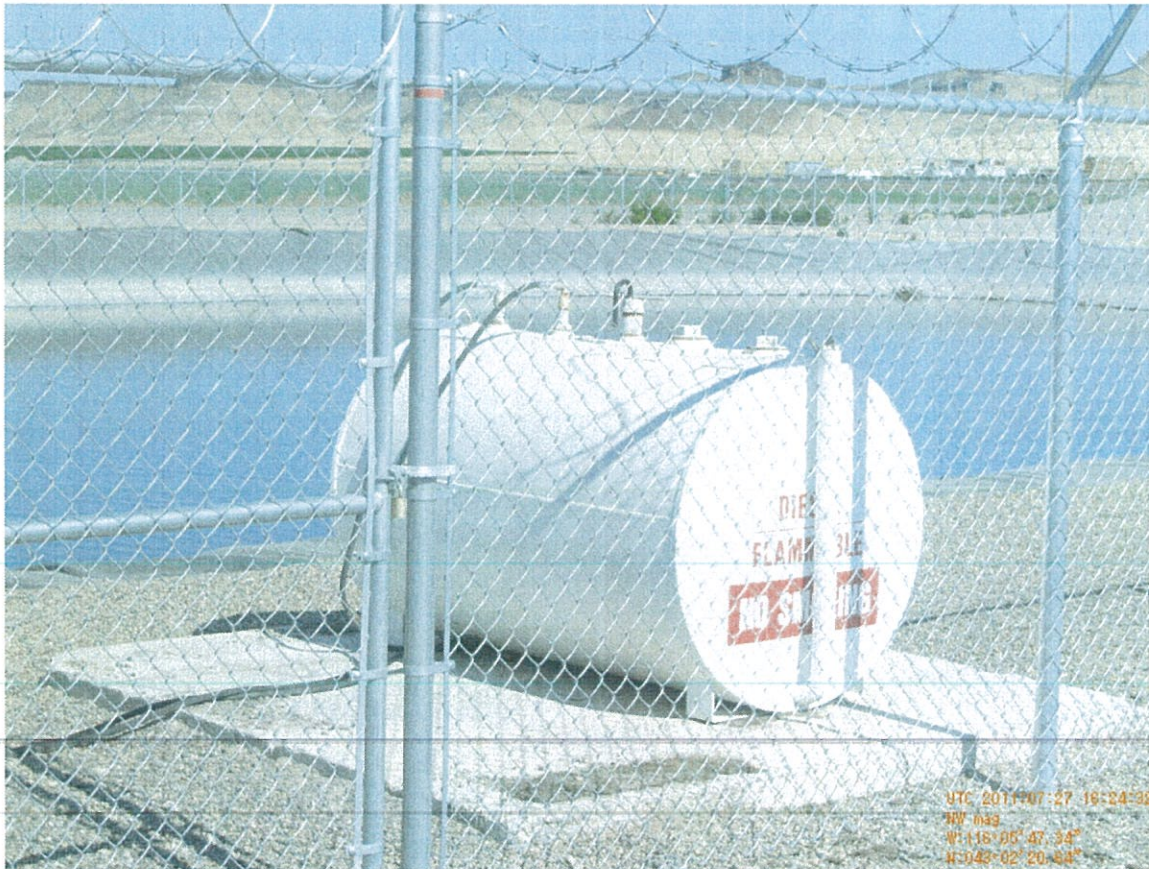
Photograph 16: Facing northwest, the photograph shows the lined storage pond, the security fence surrounding the pond, and a diesel tank for the backup generator. Mr. Parks of Simplot stated that the diesel tank was approximately 500 gallons.

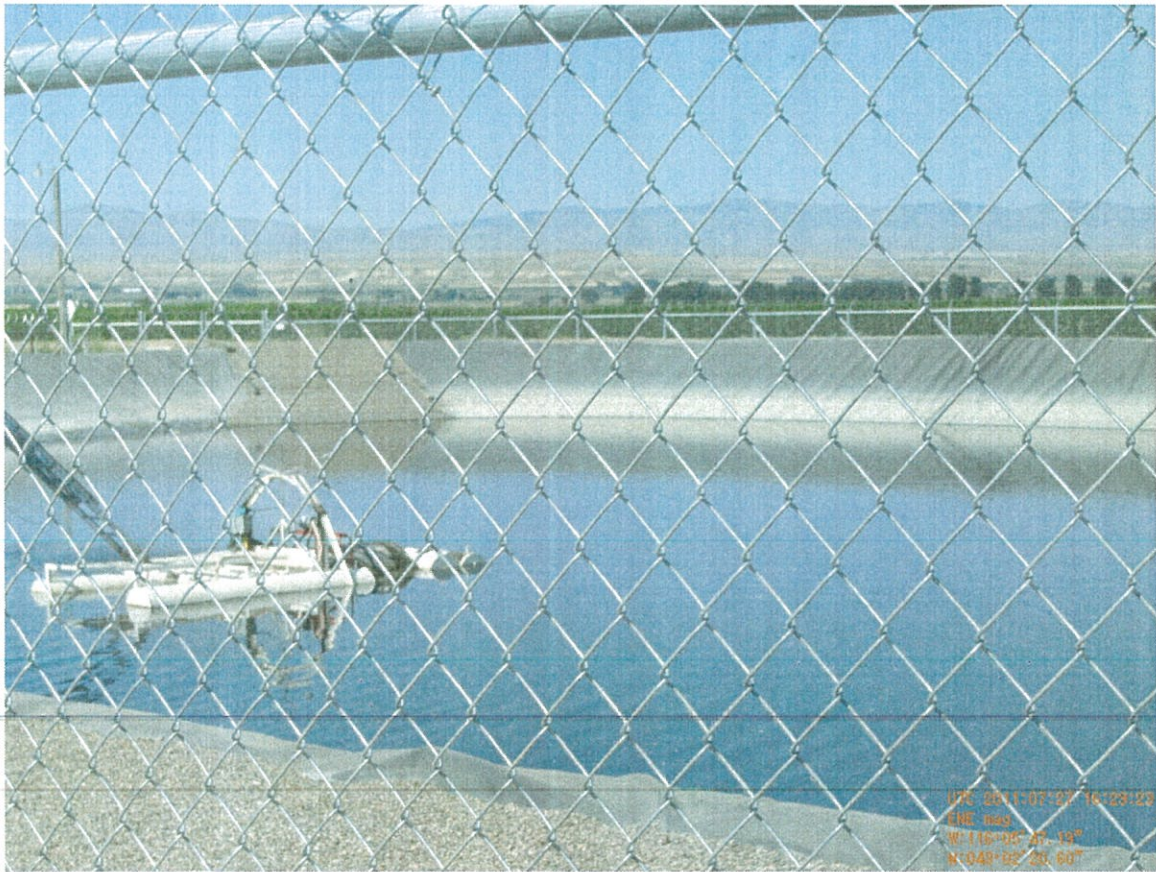
Photograph 17: Facing northwest (note error in photograph states that the photograph is facing northeast), the photograph shows the lined storage pond that Simplot constructed to contain, treat, and recirculate the source water overflow for watering cattle and dust suppression. Simplot placed gravel over the synthetic liner in the top right portion of the photo to allow an individual to climb out of the lagoon in case of an accident.
